P1287 or P1288 DTC Error Codes on 2006-2011 Honda 1.3L Hybrid Engines

The AERA Technical Committee offers the following information P1287 or P1288 DTC (Diagnostic Trouble Codes) on 2006-2011 1.3L Honda Hybrid engines. These codes may be observed as intermittent or continuous.

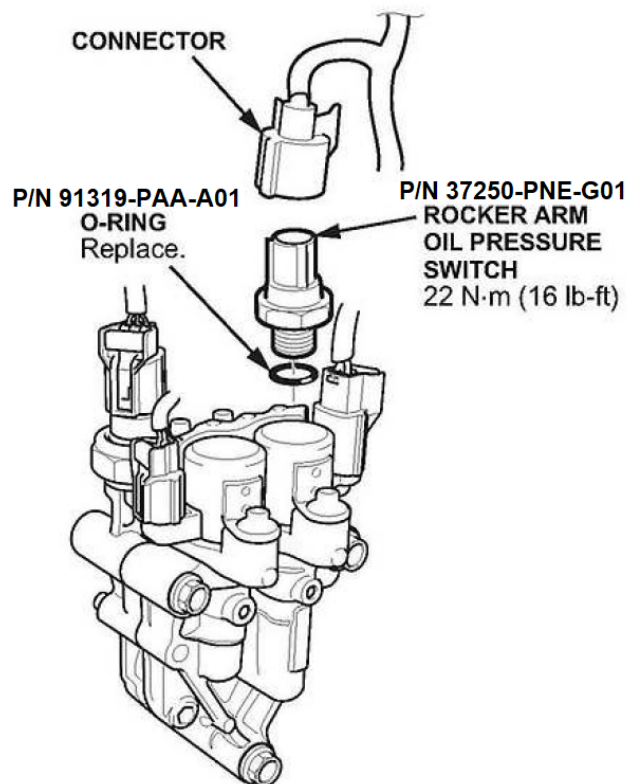
Figure 1. Rocker Arm Switch

POSSIBLE CAUSE - The rocker arm oil pressure switch may fail intermittently.

CORRECTIVE ACTION - Replace the rocker arm oil pressure switch.

1. Remove the rocker arm oil pressure switch Part #37250-PNE-G01 and the O-ring Part #91319-PAA-A01.
2. Install the new rocker arm oil pressure switch and the new O-ring. Torque the oil pressure switch to 16 FT/LBS (22 Nm).
3. Clear the code(s) with the HDS.
