Clunking Noise on 2007-2012 Mazda 2.3 & 2.5L Engines

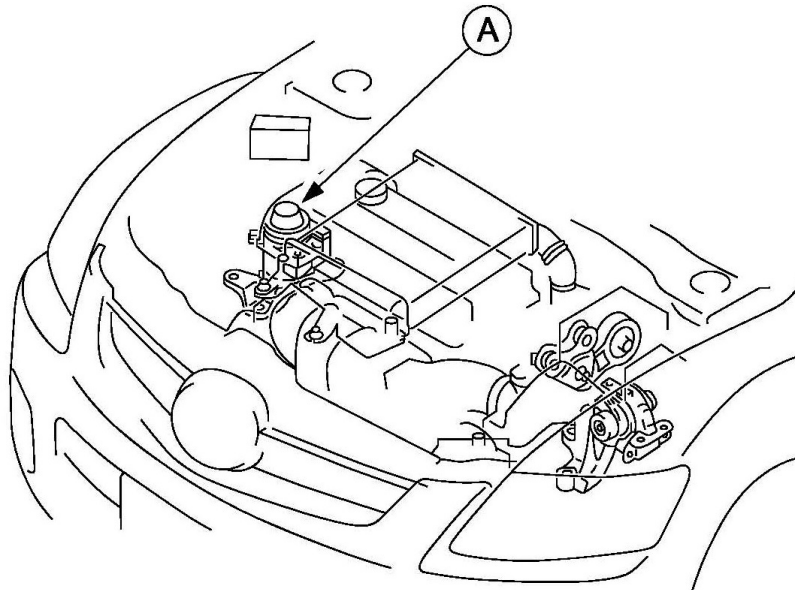
Figure 1. Number 3 Rubber Motor Mount (A)

Some vehicles may exhibit a clunk noise from the engine compartment when driving over rough roads or over a speed bump. It has been determined that due to high heat, the lubricant inside the No. 3 engine mount rubber (See A in Figure 1) may become ineffective, causing a stick-slip noise between the casing and the rubber. There is however, no oily seepage from the engine mount.

When replaced, the new engine mount rubber uses a new type of lubricant to eliminate this concern. Customers having this concern should have their vehicle repaired using the following repair parts available from Mazda.
