Engine Trouble Codes P0087, P1093 or P2293 on 2005-07 Audi 2.0L Engines

The AERA Technical Committee offers the following information regarding engine trouble codes P0087, P1093 or P2293 on 2005-07 Audi 2.0L BPG, BPY & BWT engines. These trouble codes deal with the fuel system and the pressure being too low.

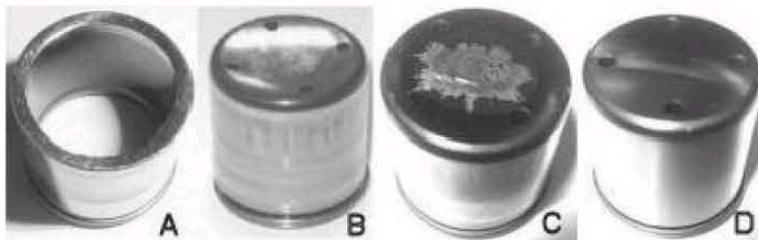
The cause of this problem seems to be excessive wear of intake camshaft lobe that drives the high-pressure fuel pump. The wear limits maximum pump piston lift, causing fuel rail pressure fluctuations. The wear on the camshaft lobe can also lead to wear on the base of the high-pressure fuel pump cam follower.

If the base of the camshaft follower looks like C or D, figure above, no excessive wear is present. Cam follower and camshaft should NOT be replaced. If the cam follower base surface is excessively worn so that its surface is concave B or missing A, as shown in the figure above, inspect the intake cam shaft lobe for wear. If excessive wear of the cam follower is found, an oil change should be performed on the vehicle following the repair.

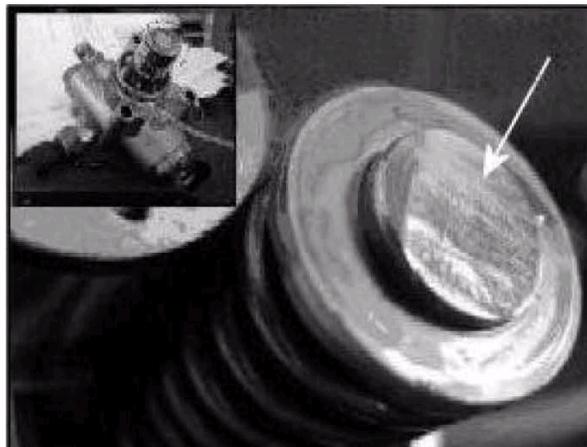
Inspect the tip of the high-pressure fuel pump plunger for excessive wear, figure above. If plunger tip of fuel pump is NOT WORN, DO NOT REPLACE the fuel pump. If excessive wear is found the high-pressure pump must also be replaced.

High pressure fuel pump plunger damage is only possible if the cam follower base has a hole in it and the plunger tip has come in direct contact with the camshaft lobe. If excessive wear of the cam follower is found, an oil change should be performed on the vehicle following the repair.
