### Rear Main Bearing Seal Caution On 1939-71 Jeep 2.2L Engines

The AERA Technical Committee offers the following information on rear main bearing seal caution on 1939-71 Jeep 2.2L engines. These engines are sometimes referred to as the F & L head engines.

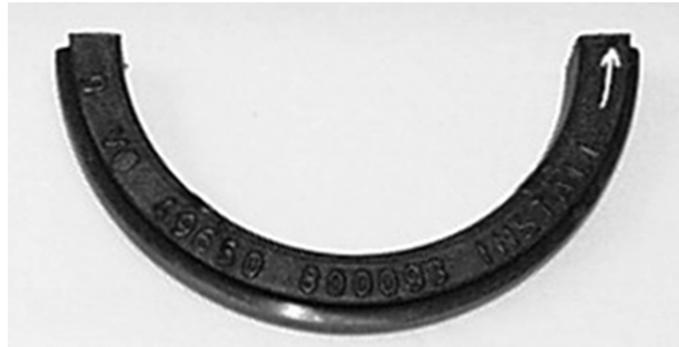
When assembly of these engines is taking place, making sure you have the correct type of seal will help prevent engine failure. If the conventional rear main seal is installed in the early blocks that required a rope seal, there may be a possibility of bearing failure. On the conventional seal is an arrow showing the direction of crankshaft rotation as shown in Figure 1.

This arrow (marked with white) should be visible from the rear of the engine when properly installed.

One way to verify that you are using the correct rear main seal is that the conventional seal is used on crankshafts that have a rear crankshaft seal area of 2.302-2.312". The rear main bearing seal has to be lubricated during installation. If the seal is too tight, no amount or special type of lubricant will make it work properly. Rear main bearing seal fit has to be correct or a leaking rear main bearing seal and/or a possible rear main bearing problem can occur.
