Oil Pump Sprocket Bolt Removal Caution On 2007-10 Nissan 1.8L Versa MR18DE Engines

The AERA Technical Committee offers the following information regarding the oil pump sprocket bolt removal on 2007-10 Nissan 1.8L Versa MR18DE engines. Improper removal of the bolt could cause damage to the crankshaft sprocket.

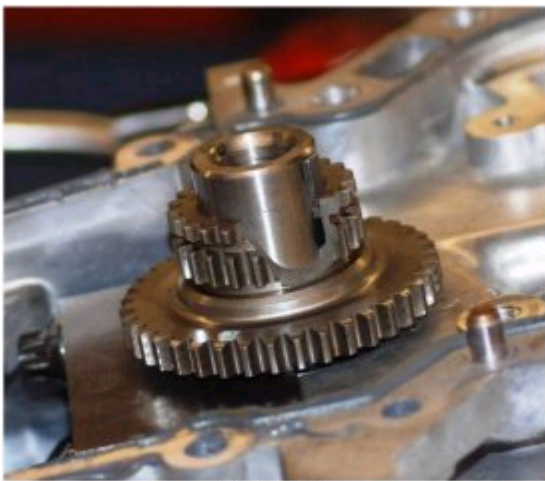
Figure 1

Proper removal of the oil pump sprocket bolt is to use hand tools; never use an impact. If an impact or other power tool is used, the crankshaft sprocket may break as shown in Figure 1.

Nissan suggests always using hand tools with a backup wrench as described in the procedures listed below. Following the procedures listed will not damage the crankshaft sprocket when removing the oil pump sprocket bolt.
