## Engine Vibration on 2006-2016 Hyundai 2.0 & 2.4L Engines

The AERA Technical Committee offers the following information on engine vibration for 2006-2016 Hyundai 2.0L & 2.4L engines. This information should be considered anytime the engine is being assembled or whenever an engine vibration exists.

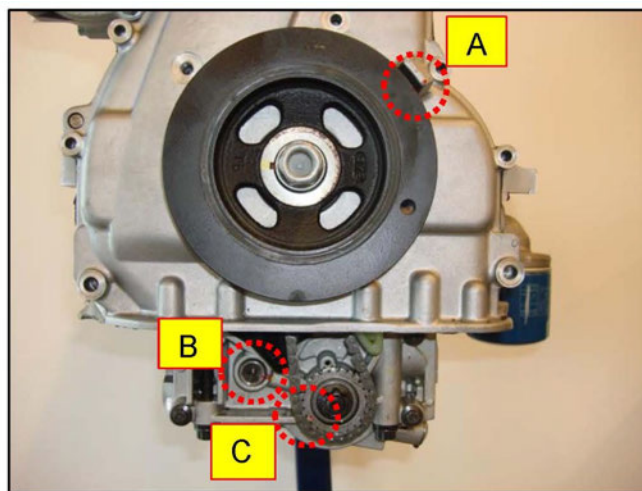
Locate the timing marks for (A) crankshaft pulley and timing chain cover, (B) counter balance driven shaft and housing, (C) oil pump driven sprocket and housing as shown in Figure 1.
