Cylinder Head Bolt Threads Stripping On All BMW Aluminum Block Engines

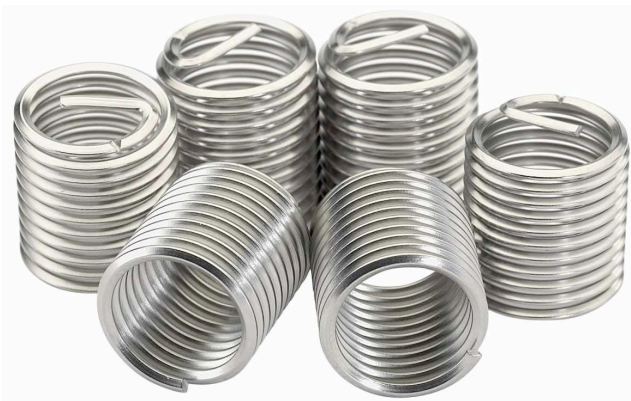
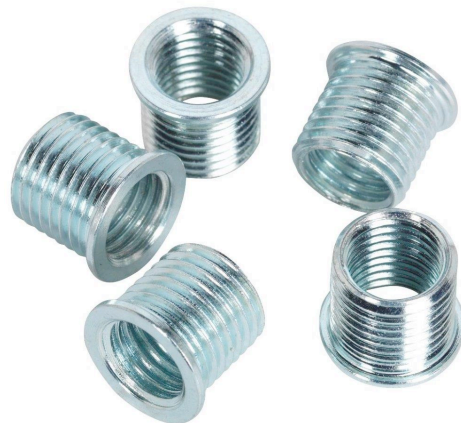
This problem will typically occur on engines that have been overheated. The overheating condition has changed and weakened the structure of the aluminum block assembly in the area of the bolt threads.

1. Before removing the cylinder head, loosen and retorque each bolt to ensure thread strength and integrity.
2. If the engine block threads strip (pull out of the block) during the retorque, replace the engine block or you can re-thread the stripped out holes with aftermarket repair inserts similar to the one shown below.
3. If all head bolts achieve correct torque, proceed with cylinder head removal. Once removed, use a straight edge on the block surface, as well as the cylinder, head to determine if any deviation caused by the overheat is present. If applicable, be aware of any protrusion of the cylinder liners above the surface of the engine block.
