Turbocharger Failure on 1999-2012 Subaru 2.5L Engines

The AERA Technical Committee offers the following information on turbocharger failure on 1999-2012 Subaru 2.5L engines. Subaru believes the main cause of turbocharger failure is lack of lubrication due to insufficient engine oil maintenance.

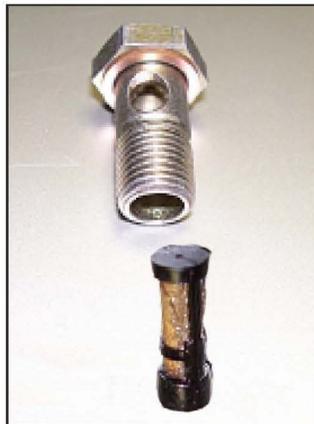
Figure 1. Banjo Bolt

**Banjo bolt and Mesh Screen
(note direction of screen)**

- Make sure the mesh screen is installed in the proper direction as shown in Figure 1; incorrect installation will cut off oil supply to the turbo.
- Do not confuse the oil supply mesh screen with the AVCS union screw filter which looks similar, but, the filter was removed from production engines in April of 2005. If a union screw filter is encountered, it should be removed and the previous union nut replaced with the new Part #15194AA270.

The mesh filter screen is only available with the purchase of a new banjo bolt, Part#14445AA090 which comes with 2 new washers. The new banjo bolt should be torqued to 21.4 FT/LBS.
