Engine Oil Leak on 2004-2016 Nissan 5.6L VK56DE Engines

The AERA Technical Committee offers the following information concerning an engine oil leak on 2004-2016 Nissan 5.6L VK56DE engines. This information should be considered anytime the engine is being checked for engine oil leaks or when block service work is being performed.

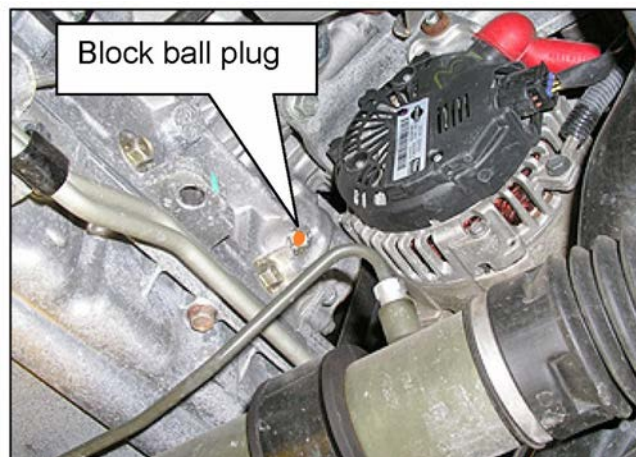
If the technician can confirm an engine oil leak is occurring from the right side of the engine block, this concern may apply. Oil may be leaking a right side block ball plug behind the alternator as shown in Figure 1 below.

Figure 1. Block Ball Plug Location

To resolve the leaking condition, use an appropriate punch to seat the block ball plug in the hole, refer to the service procedure listed on the following page.

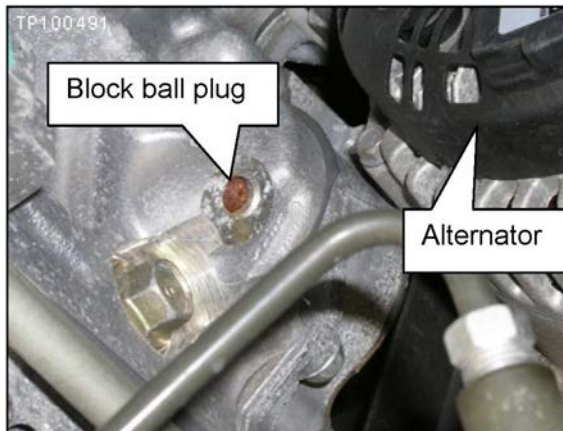
Figure 3. Ball Plug Close-up

- Obtain a 1/4" (7.5 MM) metal drift punch and a suitable smaller hammer.
- Use the punch and a hammer to tap the block ball plug further into the hole until it fully seats (see Figures 3 and 4).
- Drive (move) the ball plug further (deeper) into the hole until it "bottoms out" (fully seats).
- You will feel the ball become solid when it "bottoms out" (fully seats) as shown in Figure 4.

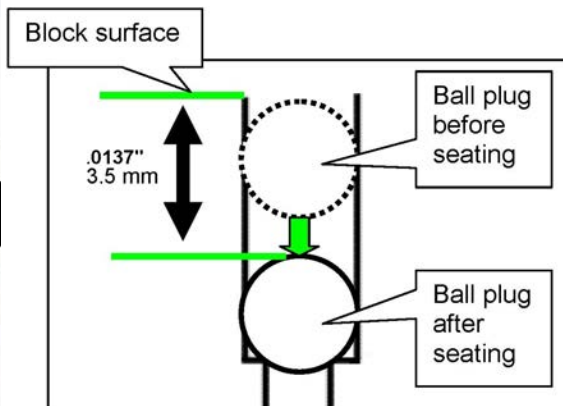
Figure 4. Ball Moved to "Seated"
