Oil in The Spark Plug Tube on 1989-97 Nissan 2.4L KA24E Engines

The AERA Technical Committee offers the following information on accumulated oil in the spark plug tubes on 1989-1997 Nissan 2.4L KA24E engines. This condition is usually reported after an engine misfire occurs and all cylinders have been affected.

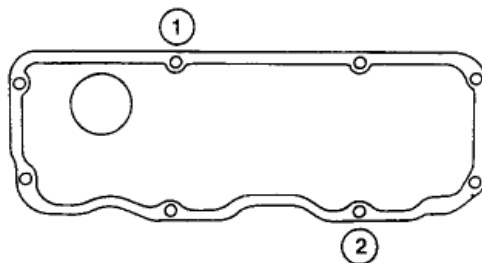
Figure 1. Tighten 2 Bolts Only in Sequence to 23 IN/LBS

- Install only the two bolts shown in Figure 1 and tighten to 26 IN/LBS
- Then, tighten the remaining bolts in sequence to 95 IN/LBS as shown in Figure 2.
- Parts are available in the aftermarket and Nissan with Part #1326486G01

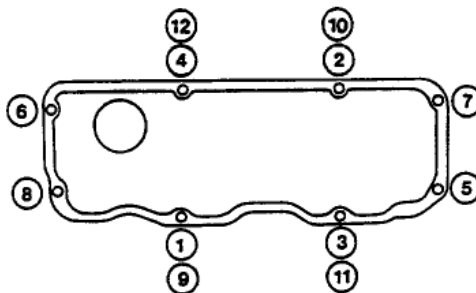
Figure 2. Tighten ALL Bolts in Sequence to 95 IN/LBS
