Balance Shaft Bushing Repair on 2008-2015 Audi 2.0L CAEB Engines

The AERA Technical Committee offers the following information on a balance shaft bushing repair for 2008-2015 Audi 2.0L, CAEB engines. This repair offers a salvage operation that is not considered by Audi as they supply no replacement bushings.

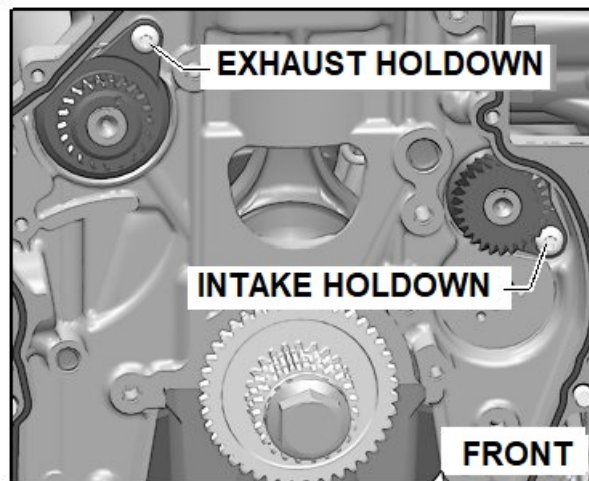
These engines utilize left and right side balance shafts which are supported by bushings on each side of the block. Those locations may be a loss of oil area if the bushings become worn. Audi supplies no dimensional specification for those bushings or the balance shafts. Although they give no reasons, Audi also states to replace either balance shaft if removed.

AERA shops report that obtaining bushings for other applications will help salvage blocks for reuse when balance shaft oil clearances are excessive. Generally, since no specifications are supplied, for the shaft sizes on these locations .003-.0035" (.076-.090 MM) would be considered excessive.

Figure 1. Front View Balance Shafts

Readily available transmission bushings have been used on these engines to successfully re-establish bushing oil clearance to approximately .0015-.0020" (.038-.051 MM). Using bushings from Durabond #26934B and Transtar #73037G with only slight modifications will help restore oil clearance for the balance shafts on these engines. Modifications include drilling an oil hole and reducing the bushing outside diameter on a lathe slightly. Audi's repair would be a complete short block to restore oil pressure.
