Front of Engine Rattle Noise on 2012-2015 Landrover 2.0L Engines

The AERA Technical Committee offers the following information on a rattle noise at the front of 2012-2015 Landrover 2.0L engines. The noise may also be accompanied with an error code such as P0016, P0017, P0026 or P0341.

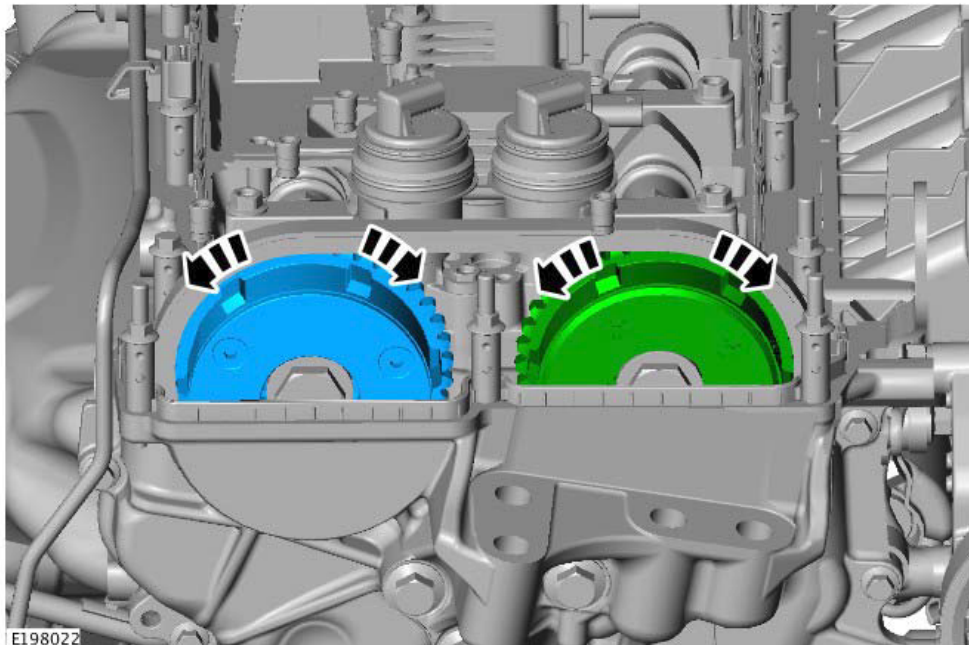
Figure 1. Blue Colored Exhaust, Green Colored Intake

The exhaust camshaft VCT actuator shown in blue in Figure 1 above has restricted movement when turned by hand. The intake camshaft VCT actuator shown in green has a less restricted movement when turned by hand.

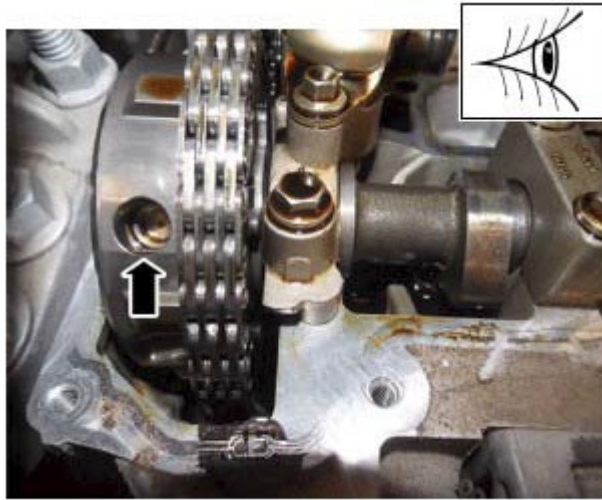
Figure 2. Plug Installed in Oil Gallery

After removing the camshaft cover, observe the plug indicated by the black arrow in the Figure 2. If the plug is missing, replace the intake VCT, if the plug is in position follow the steps listed below.

- As viewed from the front, fully rotate the camshaft counter-clockwise and then attempt to rotate the camshaft clockwise.
- If the camshaft rotates freely in both directions, the VCT actuator is not functioning properly and requires replacement with improved Part #LR050849.
- If no clockwise movement was possible without also rotating the engine, the VCT actuator is functioning properly, no replacement is recommended.
