## Cummins Reuse Guidelines for Roller Camshafts and Followers/Tappets

The AERA Technical Committee offers the following information regarding camshaft and tappet reuse for Cummins diesel engines using roller components. The following information is suggested for consideration any time camshaft and tappet service is being evaluated.

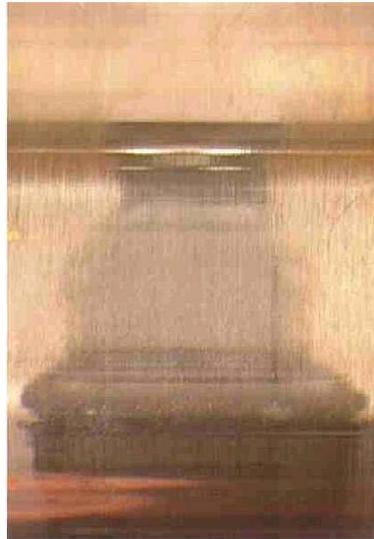
**Figure B. Polished**

**Polishing:** Normal surface condition where machining lines have been smoothed from contact between mating parts (see Figure B).

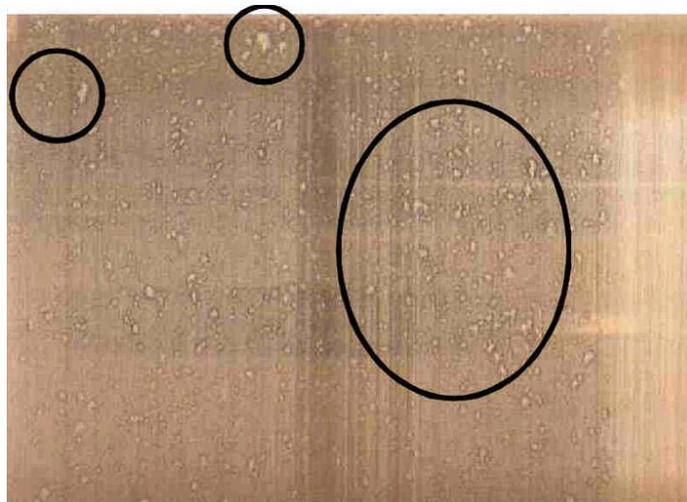
**Figure C. Dented**

**Denting:** A depression left in the surface by a piece of foreign material that is trapped between the lobe and roller. A dent has a relatively smooth, shiny bottom and does **not** have rough or sharp edges (see Figure C).

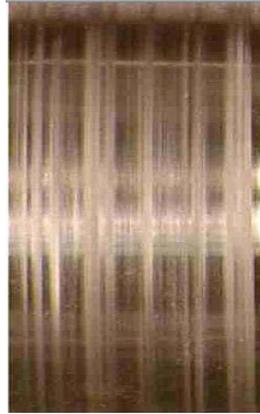
**Figure D. Frosted Bands**

**Frosted Bands:** A high-density micro-denting. Frosted (white) in appearance. Frosted bands are **not** detectable with a fingernail (see Figure D).

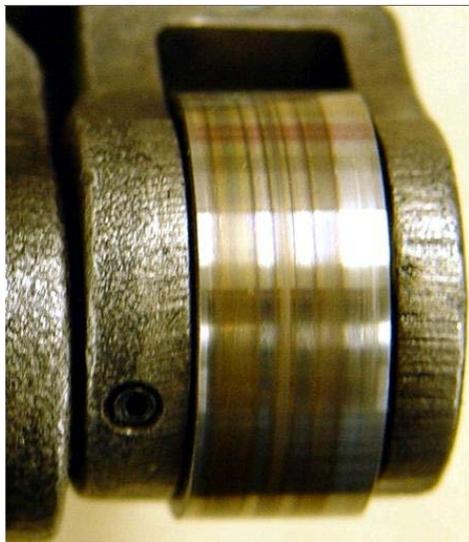
**Figure E. Varnished Bands**

**Varnished Bands:** Surface film of oxidized oil. Brown or blue color in appearance. Varnished bands are not detectable with a fingernail (see Figure E).

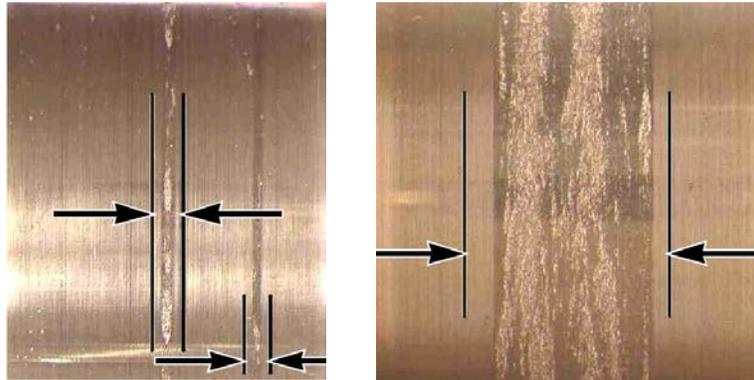
**Figure F & G. Galling**

**Galling:** Transfer of small pieces of material between the follower roller and the camshaft lobe surface by welding one surface to the other (see Figures F and G). Galling typically occurs when a follower roller skids on the camshaft lobe surface. This damage is detectable with a fingernail.

1. If multiple gall streaks are present but **not** connected, apply the width criteria to each streak individually.
2. Do **not** reuse the camshaft if the engine is being overhauled or if the camshaft is out of the engine.
3. Do **not** reuse the camshaft if the engine is being overhauled.

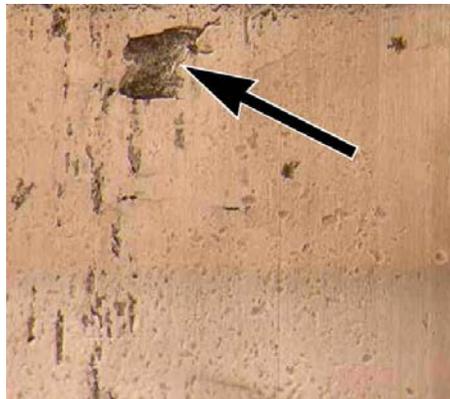
**Figure H. Pitting**

**Pitting:** Loss of a piece of material from the lobe resulting in a hole that is visible to the naked eye. Pits typically have rough, dark bottoms and sharp edges, and usually occur in the heavily-loaded areas of the lobe (see Figure H).

H	Pitting	Replace	All
I	Macro-spalling	Replace	All

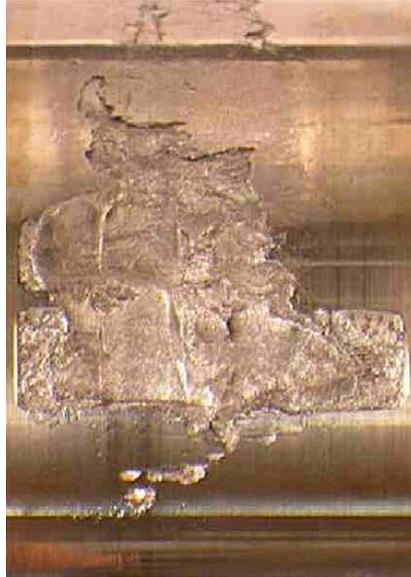
**Figure I. Macro-Spalling**

**Macro-Spalling:** Loss of large pieces of material from the lobe surface (see Figure I). This amount of damage will affect the operation of the engine.

**Lubricating Oil System Inspection:** In the event that macro-spalling is observed, inspect the lubricating oil filter for metallic debris. If metallic debris is found in the filter, inspect and replace as necessary the main and rod bearings, camshaft bushings, turbocharger, lubricating oil pump and pressure regulator and the lubricating oil cooler.
