Cylinder Liner Cavitation Erosion On Diesel Engines

The AERA Technical Committee offers the following information on cylinder liner cavitation erosion on diesel engines. This information should be considered anytime maintenance is being performed on a diesel engine.

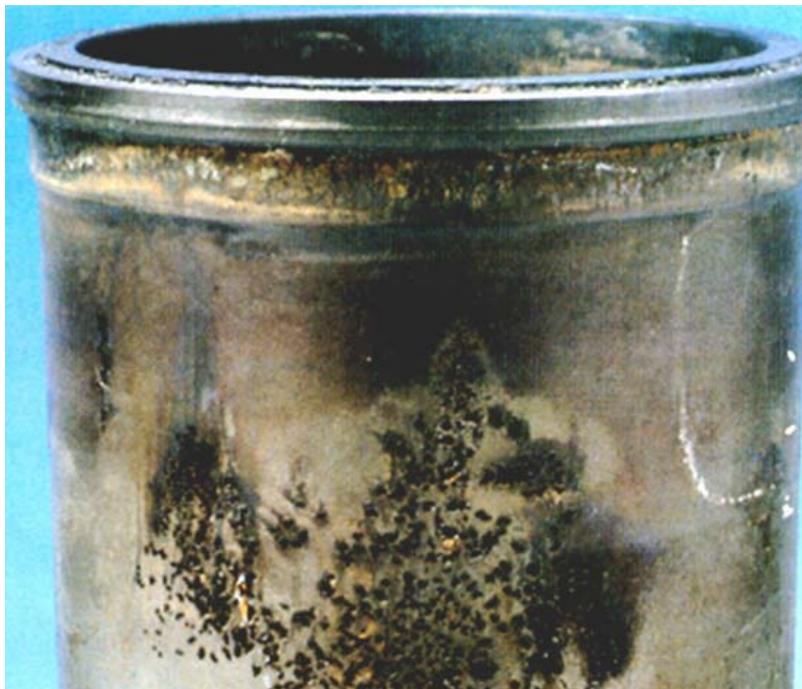
Figure 1. Severely Eroded liner

The affected areas form vertical strips or patches sometimes in alignment with the thrust face of the piston within the cylinder, or also formed immediately over the top sealing ring of the liner. The erosion can penetrate the wall of the cylinder and permit the flow of antifreeze/coolant to the oil or vice-versa.

The cavitation erosion is caused by excess in harmonic vibrations of the engine and in some cases by loose fitting liners that result in a fast formation and implosion of small vapor bubbles within the coolant which attack the cylinders' liner wall. The vibration in combination with collapsing bubbles produces an

We can say that the wall of the sleeve, which comes in contact with the coolant, quickly moves inwards and outwards striking these vapor formations. During this process, tiny bubbles are formed that implode or collapse violently producing shock waves against the liner's wall. The results of these implosions at the impact area of the liner's wall have been calculated to reach over 10,000° F with pressures of over 10,000 psi.

In many cases, cavitation can be avoided by reducing harmonic vibrations. For example, by making sure the injection complies with the manufacturer's specifications, the engine's speed is governed according to the manufacturer's data and that the control functions. Also, do not underestimate the importance of correct clearances between liner and cylinder blocks; incorrect liner fit is a serious contributor to liner vibration resulting in cavitation erosion.

Engine manufacturers have specific additives for the coolant called SCA (supplementary cooling additive). These additives will form a protective coating over the cylinder liner, which is exposed to the coolant, therefore reducing cavitation damage. With time, additive concentration reduces in the system, consequently making it necessary to follow system maintenance recommendations in order to keep the adequate levels.
