Timing Gear Caution on 1993-2013 Dodge/Chrysler 3.5L Engines

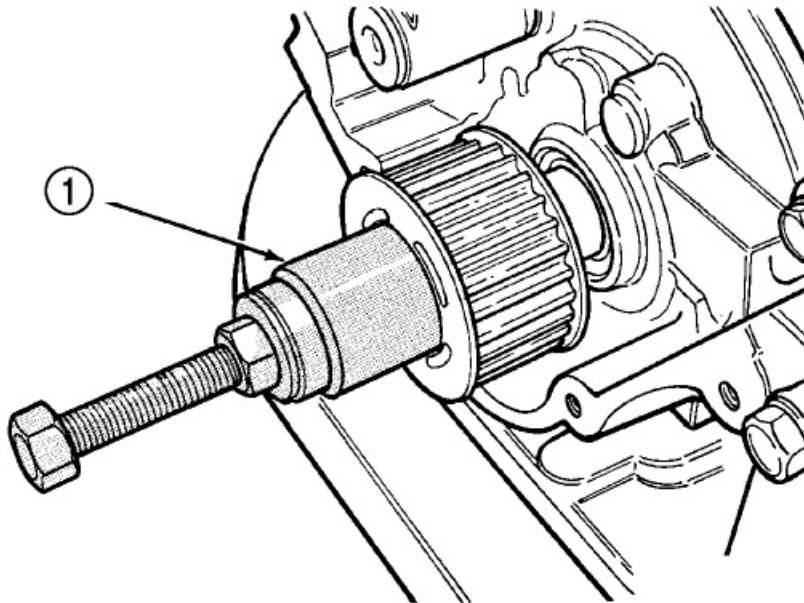
Crankshaft Sprocket - Installation

The AERA Technical Committee offers the following information regarding a timing gear caution on 1993-2013 Dodge/Chrysler 3.5L engines. This information applies to the crankshaft sprocket/gear, it should be noted before removal that the sprocket/gear is not located to a shoulder or raised area on the crankshaft snout. It is located a certain distance from the front end of the crankshaft.

Chrysler/Dodge suggests using their installation tool to assure correct location from the front of the crankshaft snout. This tool is available from Chrysler/Dodge or from tool manufacturer Miller SPX with tool #6641A. If a tool is unavailable, measuring the exact distance the sprocket is from the front crankshaft snout before removal will be very useful for installation of a new sprocket.

1 - INSTALL WITH SPECIAL TOOL 6641 WITH 12mm SCREW
