Rear Engine Oil Leak on 2010 Jaguar 5.0L DOHC Engines

The AERA Technical Committee offers the following information on an engine oil leak repair for 2010 Jaguar 5.0L DOHC engines. Annoying oil leaks at the rear of the above mentioned engines has been reported. Locating the source of this leak has been often times misdiagnosed as a leaking rear main seal.

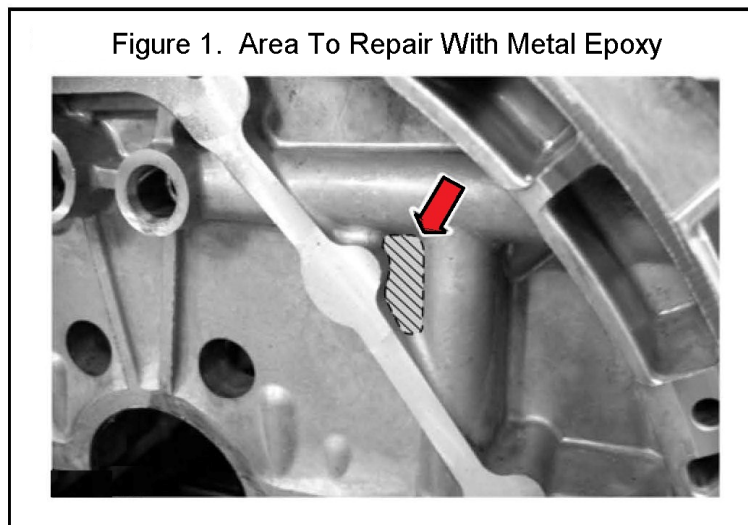
The source of this engine oil leak however is above the rear main seal in a block casting cavity shown in Figure 1. The leak may be caused by casting porosity or slight cracking in this block area. The engines high oil pressure gallery is located adjacent to the affected area. An effective metal epoxy repair such as Devcon Aluminum Putty F 10610 has been authorized by Jaguar to repair this condition.

The repair consists of first “roughing up” the area with an appropriate die grinder and then extensive cleaning with a fast drying cleaning agent. Several applications of the epoxy material should be done eventually fill the entire cavity for a long lasting repair.
