Cylinder Block Boring Caution on 2000-2006 Toyota 1.8L 2ZZGE Engines

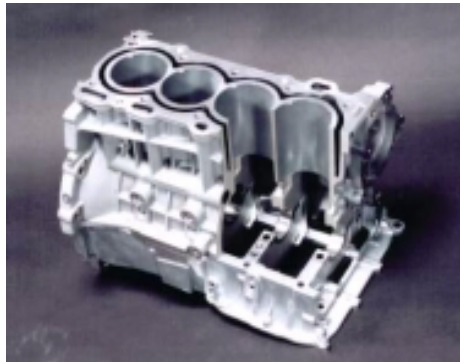
Figure 1. All Aluminum 2ZZGE Cylinder Block

This uncommon material possesses boring and honing issues for most if not all machine shops. Currently, the most common bore repair is to sleeve all four cylinders with iron liners and hone with conventional methods.
