Cylinder Bore Repair Options for Komatsu 95 Series Diesel Engines

The AERA Technical Committee offers the following information for consideration for cylinder bore repair for Komatsu 95 Series diesel engines. This information should be referenced anytime major engine repair is occurring.

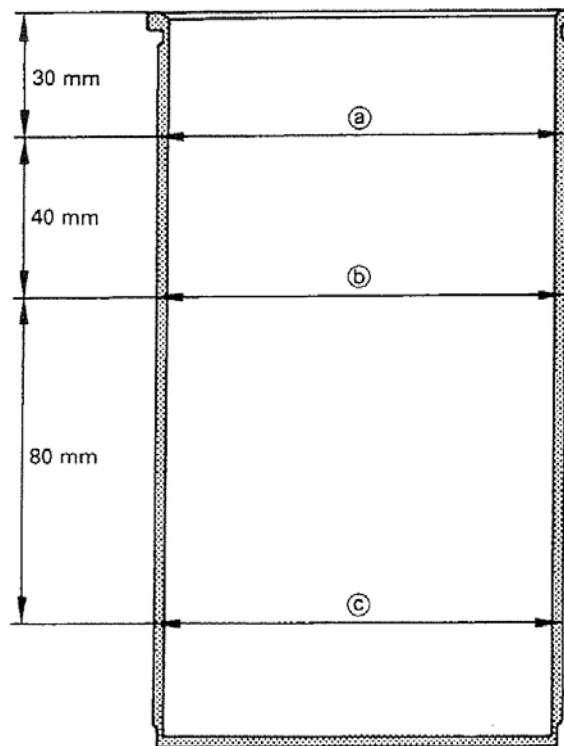
Figure 1. Measurement Locations

The engine block used in the 95 Series of engines is a parent bore block which does not use a liner/sleeve at original manufacture. Many versions of these engines are built and most offer oversize bore pistons of .020" (.500 MM) and .040" (1.000 MM). If any of the blocks are worn beyond .040" (1.000 MM), the repair liner/sleeve is the required option for future use. Several aftermarket suppliers offer liner/sleeves and standard pistons for these engines.

All versions offer a sleeve repair which could be considered a repair sleeve even though it incorporates an upper sleeve flange. Two sleeve options can be used, depending on the final bored diameter. Refer to the graphics shown below to assist in repairing worn bores for these engines.

Choose the liner/sleeve A or B which best matches the final bored diameters shown in the chart below.
