Unexplained Coolant Loss on 2012-2013 Land Rover 2.0L Engines

The AERA Technical Committee offers the following information on unexplained coolant loss on 2012-2013 Land Rover 2.0L turbo engines. Depending on the amount of loss and miles driven, coolant may also be noticed in the engine oil supply.

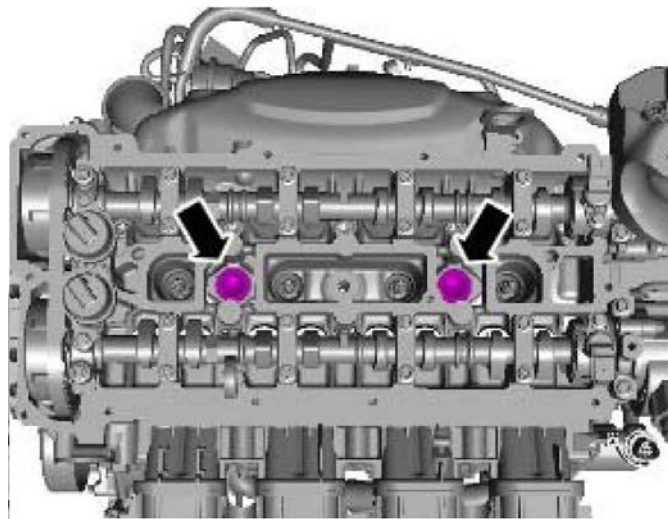
Figure 1. Core Plug Locations

Apparently, core plugs located in the top of the cylinder head (Figure 1.) may be leaking. The screw-in type plugs may have had inadequate amounts of sealer applied when installed at the factory.

In most case's a visual determination can be used to verify plug leakage as evidenced by the photos shown below. For repair, the valve cover must be removed and the plugs resealed with Loctite #R243.

- Remove the core plug.
- Clean and dry both threads.
- Inspect the threads for signs of damage, replace as required.
- Apply a continuous bead of Loctite® 243 to the core plug thread.
- Install the core plug and tighten to 55 FT/LBS (75 Nm).
- Allow at least an hour of time before start-up for sealant cure time.

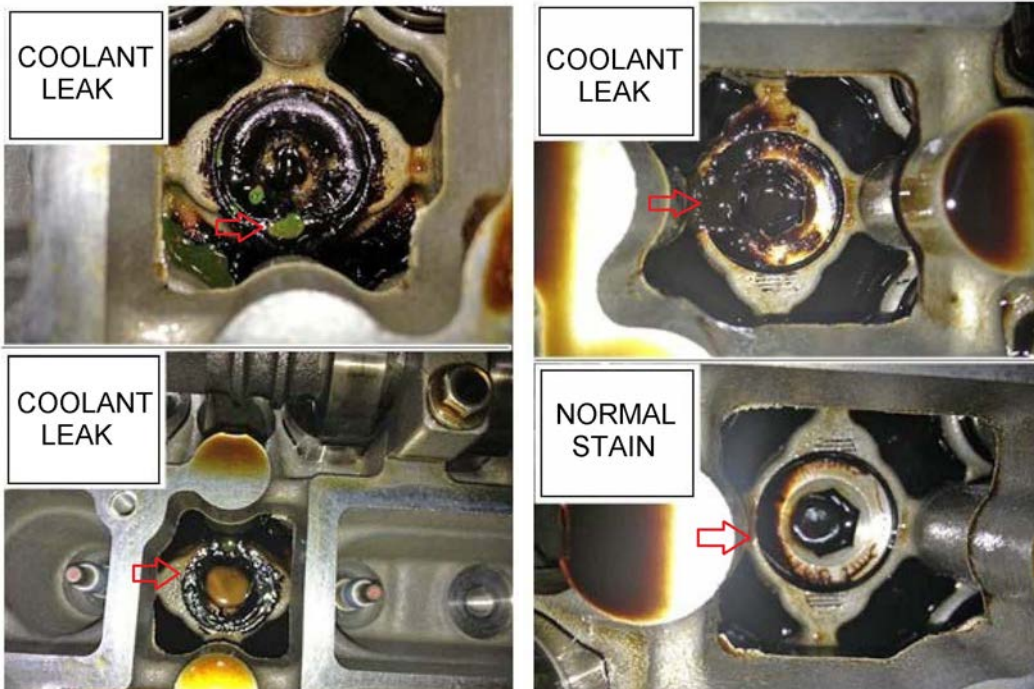
NOTE: It is important to note that if sufficient enough coolant enters the oiling system, engine damage will result.
