Lack of Power on 2010-2011 Suzuki 2.4L, J24B Engines

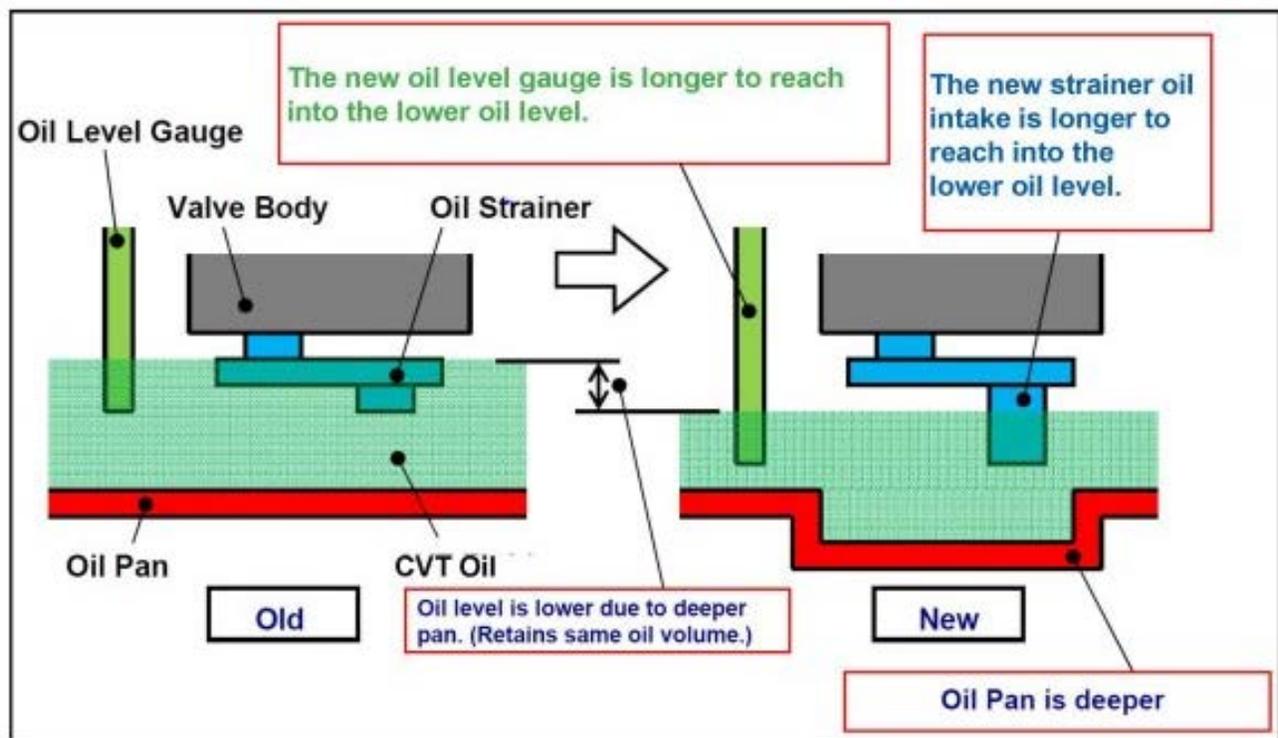
This condition may be caused when the CVT (Continuously Variable Transmission) oil temperatures become extremely high due the high engine loads and the CVT power reduction system becomes active and the engine power is reduced. Design changes to the oil pan have increased oil pan volume and should allow oil temperatures to be maintained much longer than before. Changes were also made to the engine oil level dipstick and oil pickup screen/strainer.

It should be noted that installing the new CVT oil pan without installing the new CVT oil strainer will result in a lack of CVT lubrication and cause CVT damage. When replacing the old oil pan with the new oil pan it is important to install a new oil screen/strainer and new oil level dipstick gauge. Never reuse oil pan bolts, the oil pan gasket or the oil pan gasket once they are removed, replace them with new parts.
