## Broken Main Bearing Bolts on 2002-2009 GM 4.2L Engines

The AERA Technical Committee offers the following information on a broken bolt caution for 2002-2009 GM 4.2L engines. Many instances of broken bolts have been reported on these engines and is usually associated with a deep knock noise in the lower block. That condition may also be felt while holding a solid metal rod against the side of the lower block.

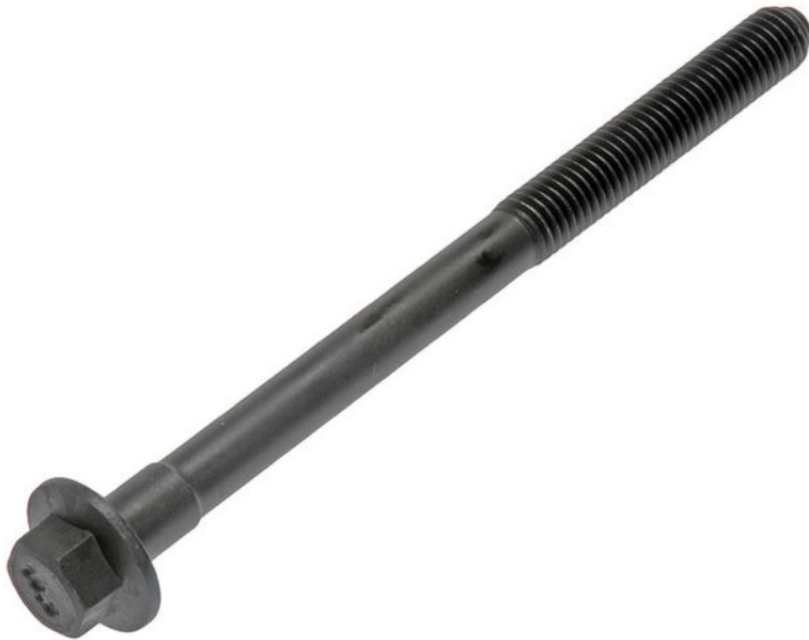
**Figure 1. Main Bolt 5&7/8" Long GM Part #11569841**

Reports have been made that the main bearing bolts may also break during engine disassembly. Replacing these bolts is now common as aftermarket suppliers offer a direct replacement bolt for the GM Part #11569841 or #11569944.

GM in their service information has recognized the one-time use bolt and recommends replacing them anytime they've been removed. Many instances of USED bolt breakage has also been reported, emphasizing the need for prompt replacement.
