# Diesel Cylinder Head Teardown and Rebuild

## Ford 6.0L Power Stroke 32-valve head

This article is an overview of a typical Ford 6.0L cylinder head teardown, inspection, the rebuild steps, and different problems that we encounter during the inspection of a Ford 6.0L diesel head. For this we prepared a demo head from our inventory to provide photo views of the various steps and highlight some of the symptoms of a failing or failed head and repair/rebuild solutions.

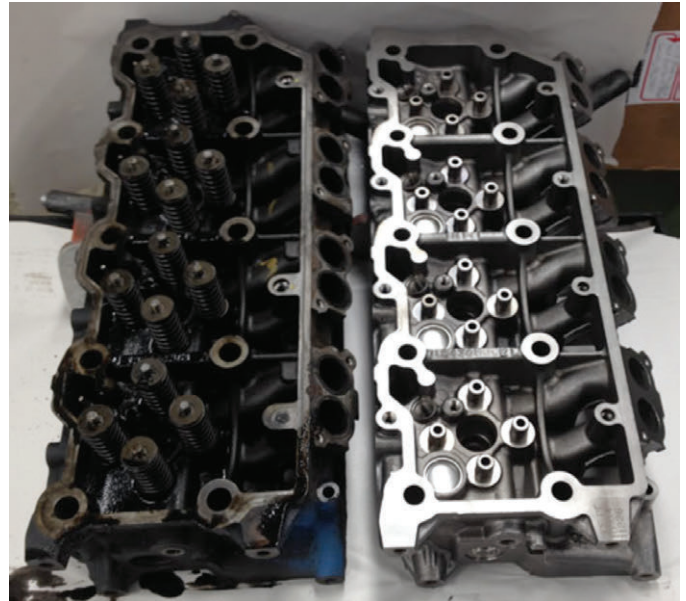
When your head arrives at UCF Machine Shop, we completely dismantle the heads for thorough cleaning. Heads go through our thermal cleaning oven and shot blast machine while components are caustic acid cleaned. At this point we give them a visual inspection for any unserviceable issues. Heads normally show some signs of head gasket leakage between the 2nd and 3rd cylinders which will be machined later to correct any problems.

Before disassembly and after cleaning and disassembly.

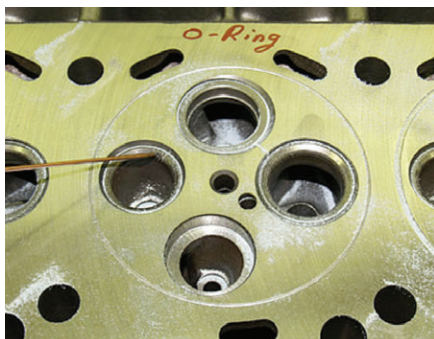
The first picture shows a crack on the actual seat of the exhaust valve. In our second picture, there is a crack between the two intake seats. The third picture is from a middle cylinder that has been severely damaged from either a bad injector or a blown head gasket. A defect this severe cannot be repaired economically by UCF.

Cracks that will not be machined out during valve seat installation are repaired with Lock-N-Stitch repair pins. While we have not found deck surface crack leaks on 6.0L heads, we still machine them out as a preventive measure.

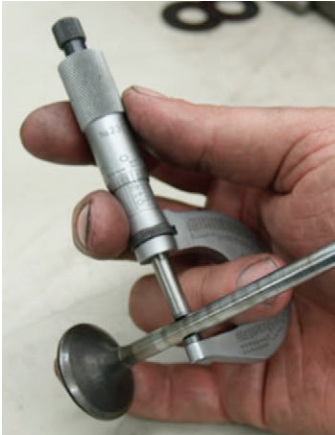
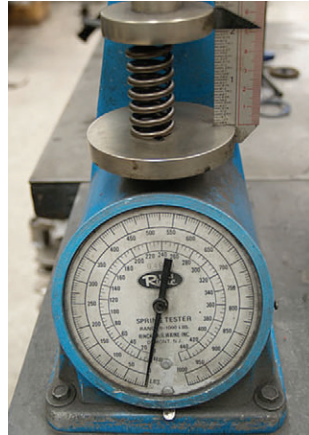
Next we inspect the valves, measure the valve stems for wear and overall length, and then test valve spring pressure. Any components worn beyond specification are replaced.

Qualifying valve stem for reuse, left; qualifying valve spring for reuse, right.

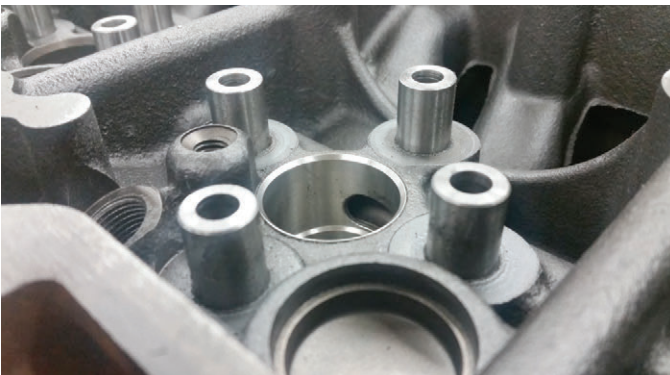
Injector Hole Sleeve - Post Installation

Our first step in machining the heads is in order to install a longer stainless steel injector cup to prevent the “fuel in coolant” issue which is prone to develop in 6.0L heads (AERA TB-2577). We have these repair sleeves specially made for us to install into the number 4 and 5 cylinder injector holes which develop the cracks leading to entering the fuel rail in the head from the coolant passages.

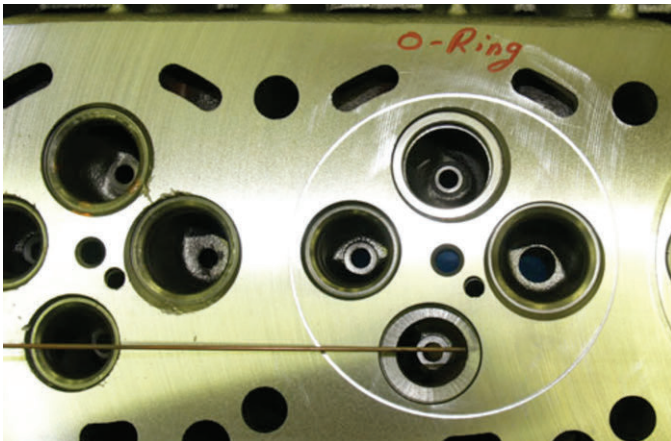
Above, machined exhaust seat counterbore. New intake valve seat installed, pictured below.

We then machine the cylinder heads to accept new hardened exhaust valve seat inserts. The exhaust valve seat is cut out to have a new valve seat insert installed.
