## Engine Oil Pan Leak on 2015-2017 Ford F150 with 2.7L Ecoboost Engines

The AERA Technical Committee offers the following information regarding leaking oil pans on the 2015-2017 Ford F150 with 2.7L Ecoboost engines. Customers may complain of an oil leak from the oil pan.

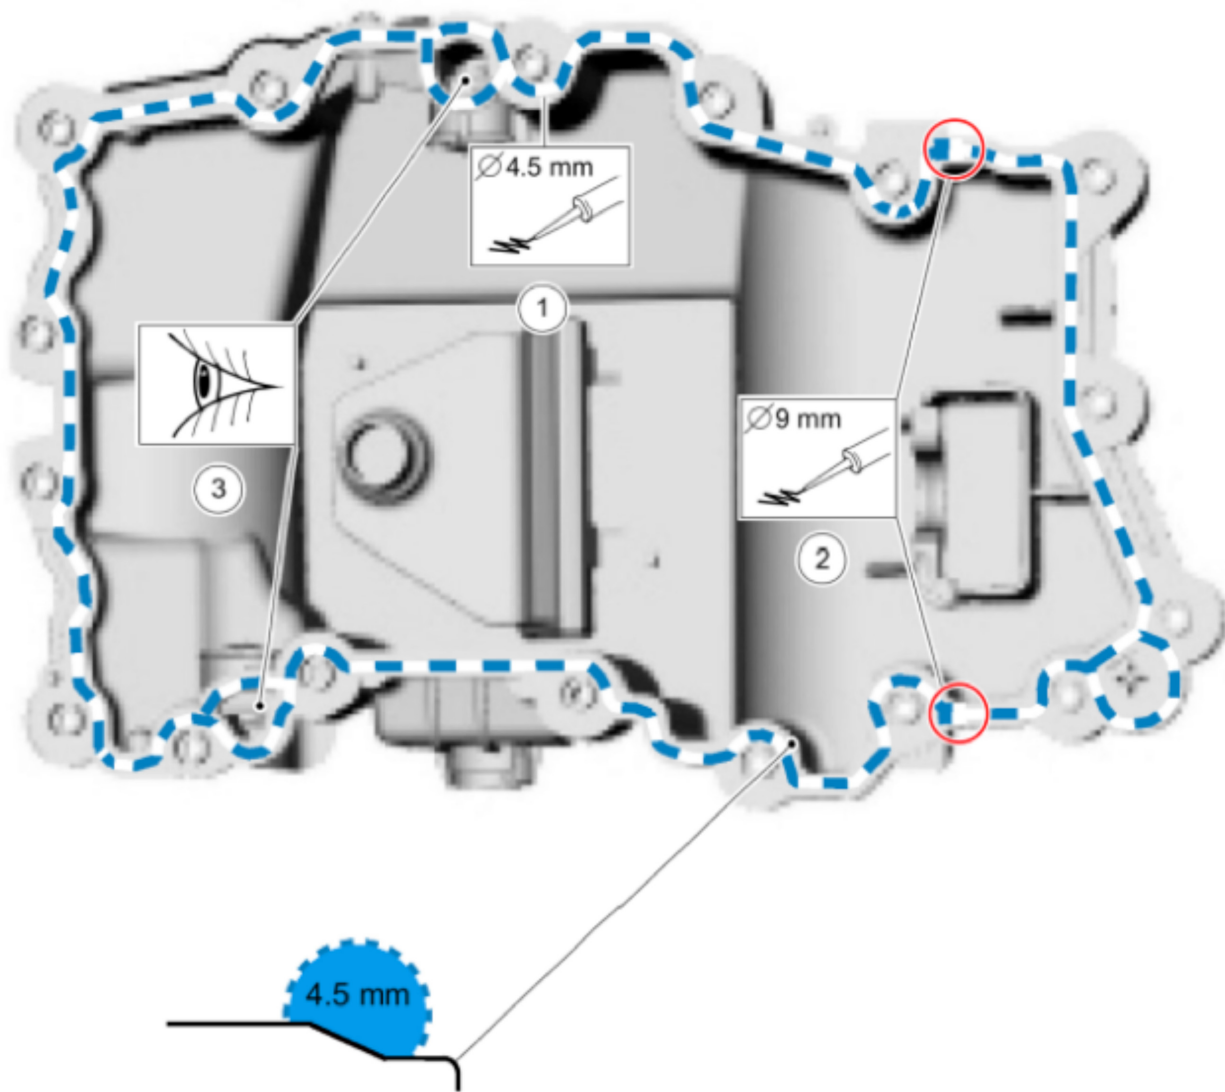
**Figure 1**

During assembly at the factory, the oil pan is sealed using an RTV sealer and the sealer used may not have the correct adhesion to the flanges leading to the oil leak. To correct this condition, the oil pan will need to be removed, the old RTV sealer removed from the mating surfaces and the surfaces cleaned to prepare for the application of new RTV sealer. Follow the procedure below to complete the repair.

- Remove oil pan from the block stiffener.
- Clean the mating surface thoroughly with a scraper and silicone gasket remover. Allow the gasket remover to set for several minutes after applying to make removal easier.
  - NOTE: **DO NOT** use metal scrapers on the pan and block flanges to avoid damaging them, use plastic scrapers instead.
- Apply a .180" (4.500 MM) bead of RTV sealer to the oil pan surface and .350" (9.000 MM) bead at the front cover and rear cover joints on the block stiffener, see red circle areas in Figure 1.
  - NOTE: Install the oil pan and torque the bolts within 5-10 minutes of applying the sealer.
