Cylinder Block Caution on 2017-2019 Ford 2.0L Ecoboost Engines

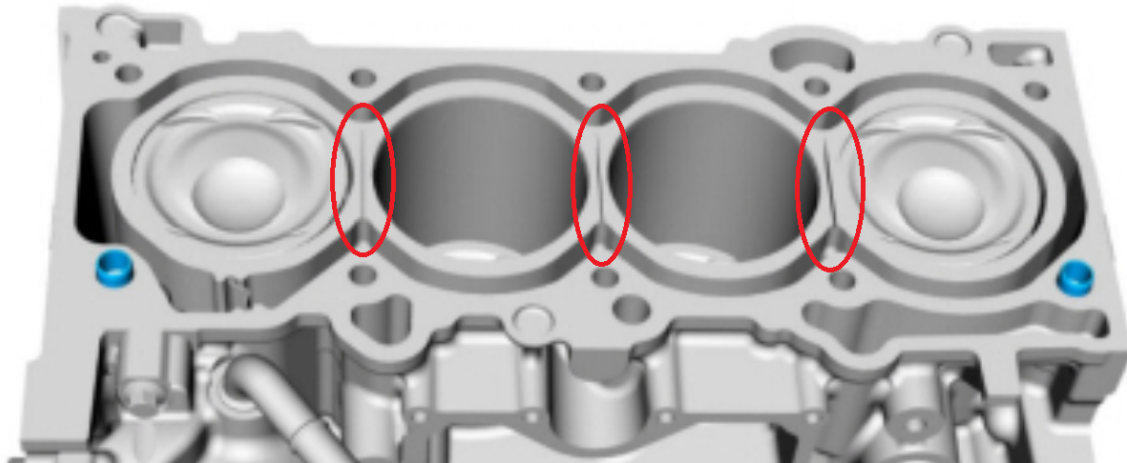
2017-2019 Design Block

There has been discussion that the slot cast between the cylinders does not provide enough clamp load surface area to properly seal the head gasket. At the printing of this bulletin, AERA does not have any documentation to verify the claim and is only cautioning our members of the problem. See Figure 1 for slot design. Ford has removed the slot starting in 2020 and instead cross drilled to allow coolant flow between cylinders. This provides more surface area to seal against. See Figure 2 for cross drilled design.

Figure 1: The slot between cylinders shown above in red circles.

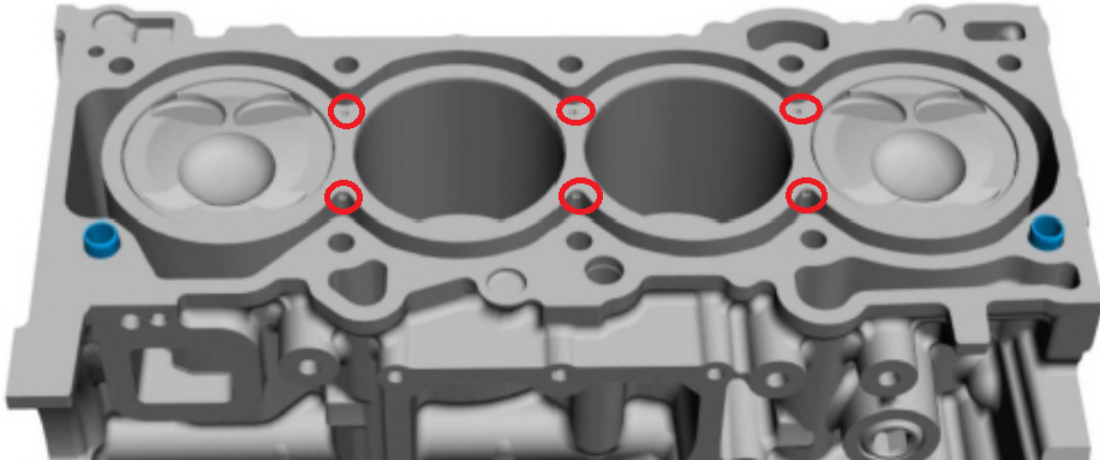
2020-2024 Design Block

Figure 2: Slot between cylinders removed and the block is cross drilled between cylinders. The coolant flows through the head, block and head gasket then across to the side of the cylinder locations circled in red.

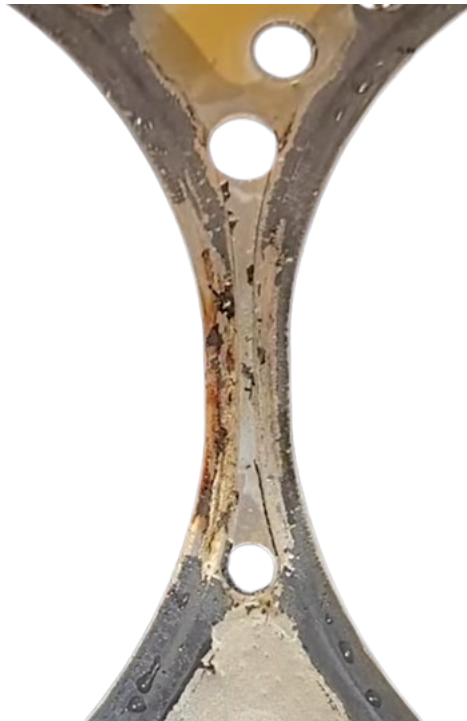
The AERA Technical Committee offers the following information regarding head gasket failures on 2017-2019 Ford 2.0L Ecoboost engines. AERA is aware of members having these engines in their shops for head gasket failure repairs. The head gasket fails, and the cylinders have coolant seep into them. This appears to be a common problem, and Ford issued a bulletin about coolant intrusion into the cylinders. They direct dealers to pull the engine and replace the long block if the condition is found.

Figure 3: Failed Head Gasket

Members who encounter the 2017-2019 2.0L Ecoboost head gasket failure need to be aware of this issue so they can make an informed decision to repair or decline the job. Servicing the engine to replace the head gasket will put the vehicle back in service but for how long before the issue comes back is an unknown.
