Engine Oil Leak on 2005-2007 Toyota 2.7L, 2TRFE Engines

The AERA Technical Committee offers the following information regarding a front engine oil leak on 2005-2007 Toyota 2.7L 2TRFE engines. Vehicle owners have complained of an excessive amount of engine oil leaking from the front crankshaft seal on the above mentioned engine.

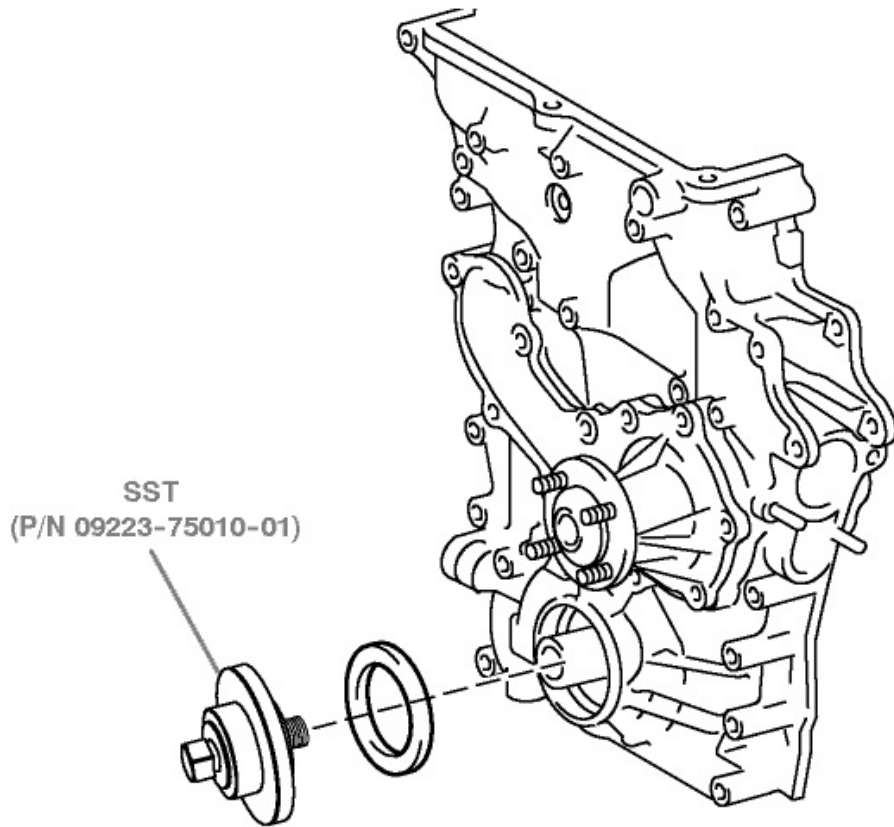
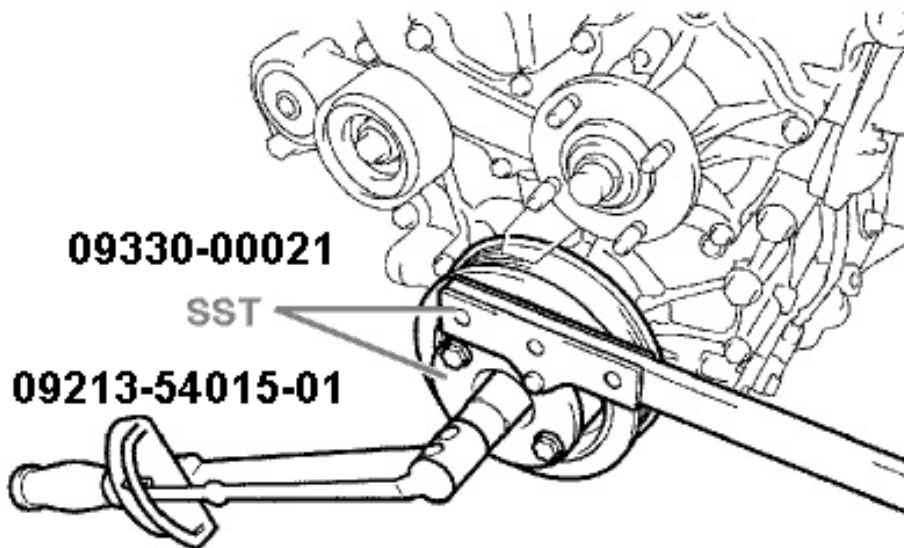
- Remove the accessory belt.
- Remove the crankshaft pulley bolt and pulley
- Remove the front oil seal.
- Install the new timing cover oil seal with approved tooling.
 -) Apply MP grease to the lip of the NEW oil seal.
 -) Place the oil seal into the correct location in the seal recess of the timing chain cover.
 -) Install the special tool Part #09223-75010-01 into the crankshaft and lightly tighten until the seal is fully seated in the timing chain cover. Do NOT over tighten.
- Remove the crankshaft bolt and special tool
- Install the new crankshaft pulley by aligning the set key of the crankshaft with the key groove of the pulley, and slide on the pulley and temporarily install a new pulley bolt.
- Using the special tools Part #09213-54015-01 & 09330-00021, hold the crankshaft pulley, and tighten the crankshaft pulley bolt to 192 FT/LBS.
