## Vented Oil Gallery Plug on 1998-2010 Dodge/Chrysler 2.7L Engines

The AERA Technical Committee offers the following information on a vented oil gallery plug on 1998-2010 Dodge/Chrysler 2.7L engines. This information applies to both cylinder heads on this V-6 engine.

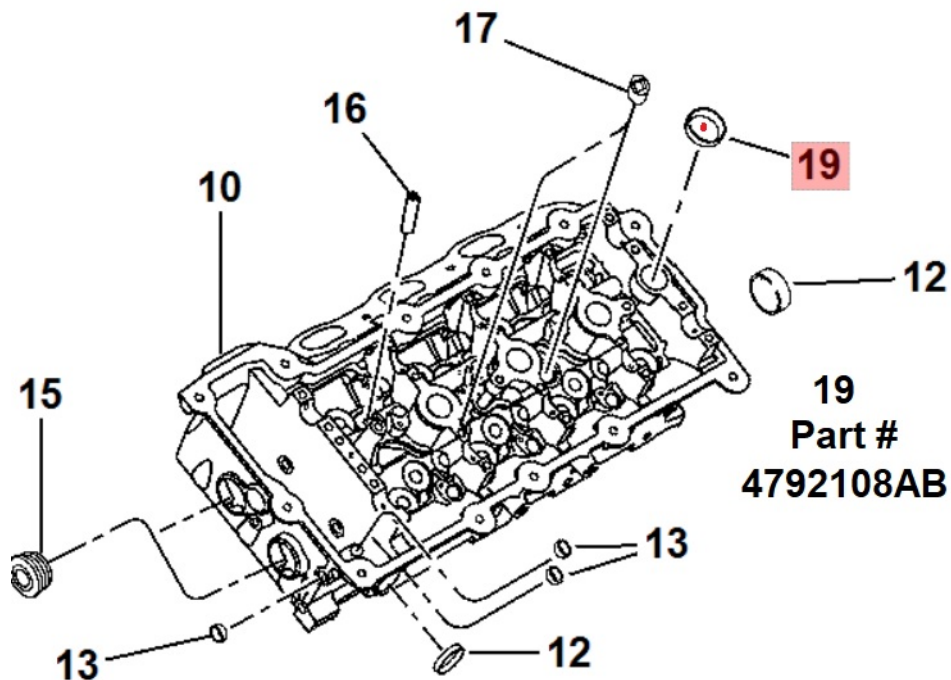
Due to the extreme engine oil sludge conditions these engines encounter, noticing the vented rear oil gallery plug location during disassembly is unlikely. The size of the hole opening is only .018" (.457 MM) and virtually unseen by the untrained eye. The 1" (25.400 MM) vented cup plug is positioned at the rear of the oil gallery to allow air to bleed from heads extensive oil galleries. Failure to provide a vented plug may result in spongy lifers and a noisy valve train.

This vented plug Part #4792108AB is available from Dodge or Chrysler dealers. Some aftermarket core plug kits do not include the vented plug and drilling a hole the proper size is not an easy task because of its small size.
