Cam Bearing Caution on Mercedes Benz OM 900 Series Diesel Engines

The AERA Technical Committee offers the following information on a cam bearing caution for the OM 900 series diesel engines. This caution expressed should be considered anytime engine disassembly is anticipated or an estimate for repair is being done. It is important to note that the Detroit Diesel Corporation also markets these engines under the MBE900 Series label.

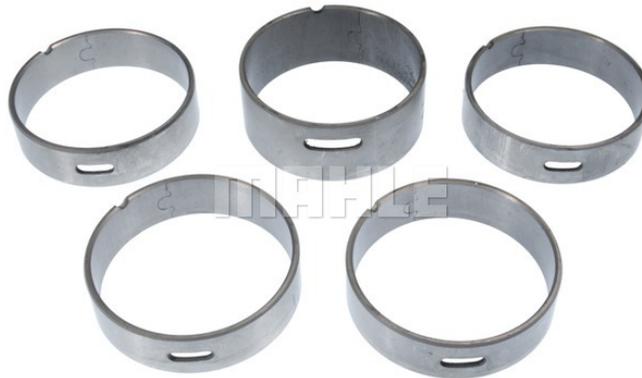
Figure 1. SH-2182S Cam Bearing Set

Aftermarket bearing manufacturers are currently supplying only a finished inside diameter bearing design Part numbers SH-2182S or SH-2204S. The dimensions are similar for both bearing sets and the SH-2182S has a single oiling hole in the front bearing and the SH-2204S has two oiling holes in the front bearing.

<u>Bearing Set Part #</u>	<u># of Front Holes</u>	<u>Bearing ID</u>
SH-2182S	One	2.6771-2.6783" (68.000-68.030 MM)
SH-2204S	Two	2.6771-2.6783" (68.000-68.030 MM)

The SH-2204S bearing set is used on later serial number engines for additional engine oiling. This bearing set could be used on earlier serial number engines, but the earlier bearing set cannot be used on the later serial number engines or engine damage will result.
