Timing Gear Failure on 1994-2002 Cummins B Series Diesel Engines

The AERA Technical Committee offers the following information on timing gear failure on 1994-2002 Cummins B Series diesel engines. This failure has been commonly referenced as the “Killer Dowel Pin” failure. While all engines manufactured in this time frame potentially have the possibility of this failure, preventive measures can be taken to eliminate this particular failure.

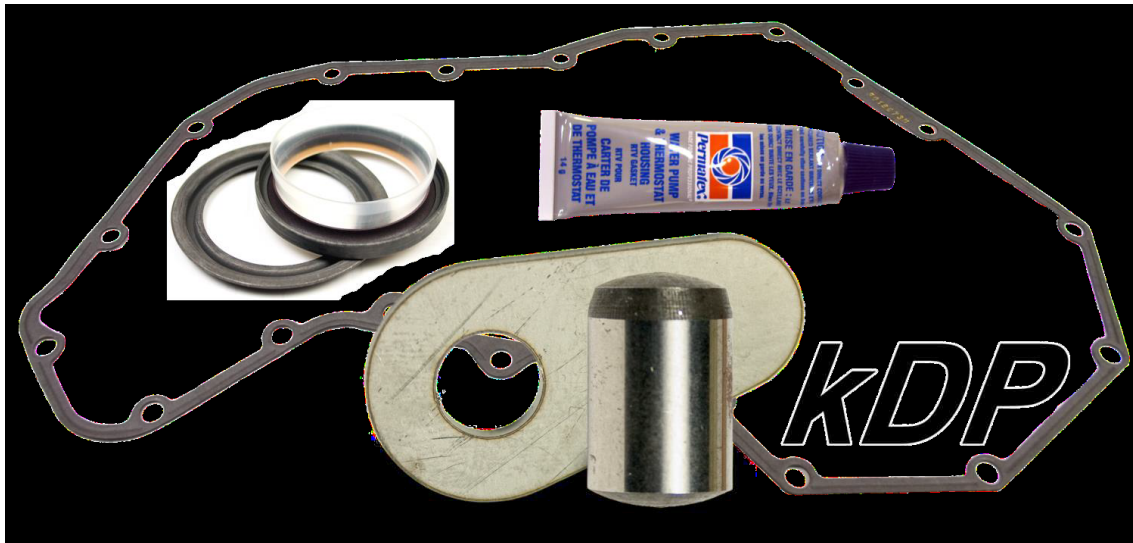
This failure is resultant of the timing cover alignment pin vibrating out of the block and falling into the valve train drive gears causing damaged gears and engine failure. The resulting damage can be catastrophic with many components breaking and destroyed.

To eliminate the possibility of this type of failure, BDPerformancediesel.com has kits for both 12 and 24 valve engine series. The installation of this kit involves removing the engine front cover and blocking the dowel pin hole, preventing it from vibrating out of its bore.
