## Rocker Arm Shaft Tightening Procedure on Volvo D9B Engines

The AERA Technical Committee offers the following information regarding a rocker arm shaft tightening procedure on Volvo D9B Engines. The following procedure must be followed correctly or damage to the rockers and shafts could occur.

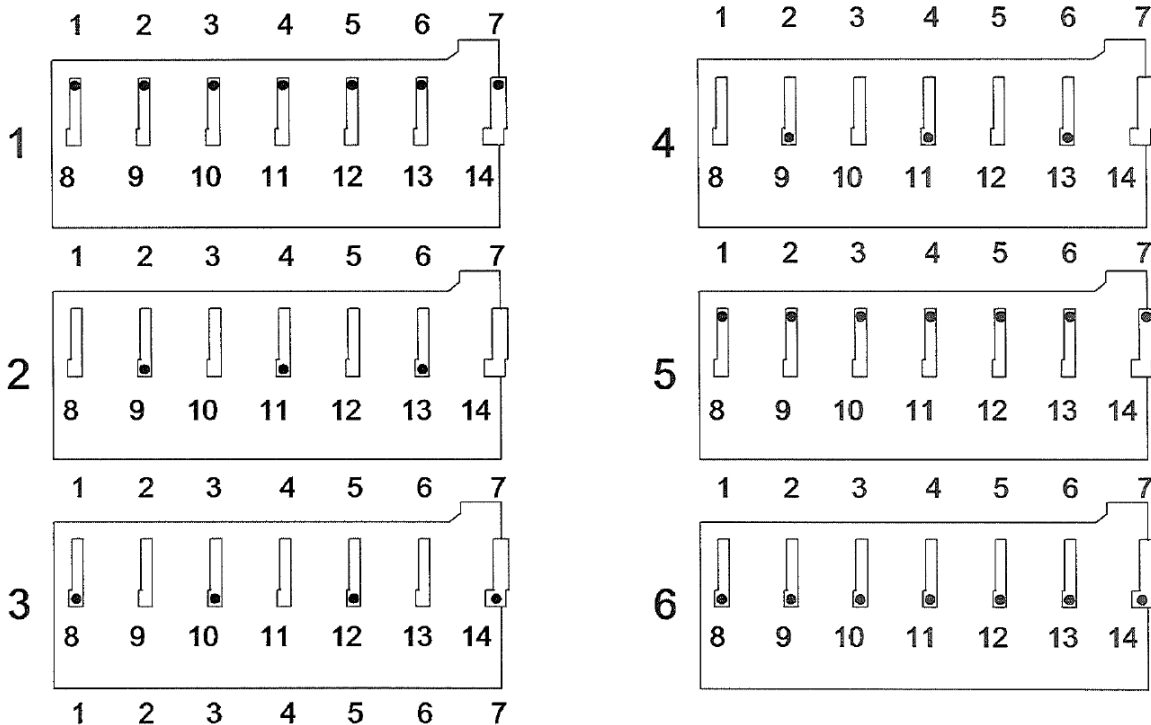
Listed below is the proper procedure supplied by Volvo. Each step listed below refers to the numbered diagrams.

- Step 1: Tighten bolts 1-7 to 9-13 ft/lbs (12-18 Nm)
- Step 2: Tighten bolts 9, 11, and 13. Begin with bolt 11 and tighten the bolts in steps to make sure that the rocker arm shaft comes down without being bent: 62-70 ft/lbs (85-95 Nm)
- Step 3: Tighten bolts 8, 10, 12 & 14 to 40-48 ft/lbs (55-65 Nm)
- Step 4: Loosen bolts 9, 11 & 13 and re-torque to 40-48 ft/lbs (55-65 Nm)
- Step 5: Angle tighten bolts 1-7 to 85-95°
- Step 6: Angle tighten bolts 8-14 115-125°
