## Check Valve Usage on 2004-2016 Audi/Volkswagen 2.0L Engines

The AERA Technical Committee offers the following information on check valve usage on 2005-2016 Audi/Volkswagen 2.0L engines. This information should be considered anytime the cylinder head is being removed.

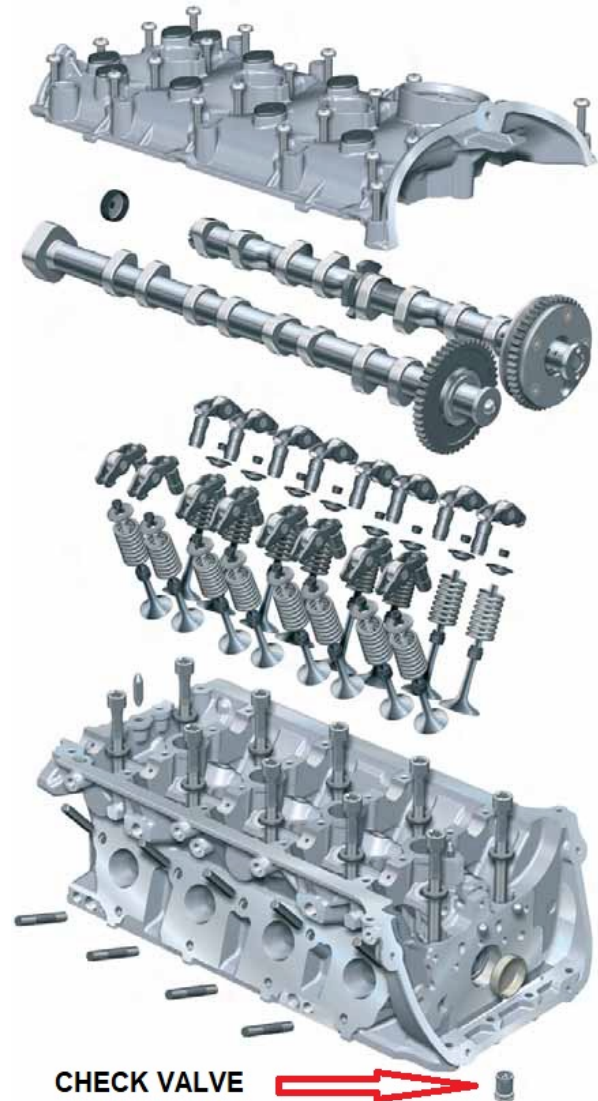
It has been pointed out to AERA that engines that use timing chains use a check valve located at the front of the cylinder head. Be sure to reinstall this check valve after thoroughly cleaning the head. Timing belt engines do not use a check valve in this location.

Timing chain uses check valve,  
pictured right.
