## **Camshaft Caution for 2007-2016 Mitsubishi Fuso 4M50 Diesel Engines**

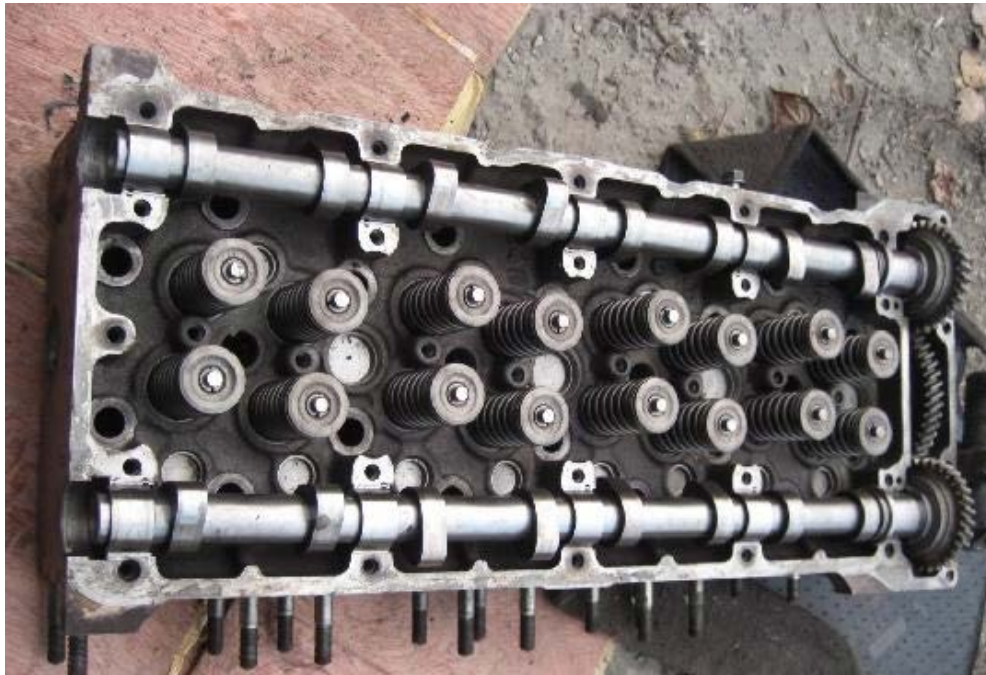
**Figure 1. Camshaft Detail**

The AERA Technical Committee offers the following information on a camshaft caution for 2007-2016 Mitsubishi Fuso 4M50 diesel engines. These engines are a DOHC (Dual Overhead Cam) design. The camshafts are what have been classified as a “hollow tube design” which consists of PM (powdered metal) lobes located on a tube and the tube is extruded to secure each lobe in place.

It has been reported there have been many instances of intake lobes moving at some point in time. This can lead to many related concerns ranging from drivability issues to piston to valve contact. Repair of this condition requires camshaft replacement. At the time of this publication AREA is unaware of aftermarket camshafts for these engines.

Intake and exhaust camshafts are available with Part #ME241668 for the intake location and Part #ME241669 for exhaust. The timing gears are not included with a new cam; they’re keyed and pressed fit for easy replacement. Since both camshafts are of the same design it is certainly possible for exhaust lobe movement as well.
