Piston Failure on Diesel Engines

The AERA Technical Committee offers the following information regarding piston failure in diesel engines. It is imperative to determine the cause of piston failure and addressing the cause before simply replacing the damaged parts and re-assembling the engine. Otherwise, similar damage will occur shortly after the engine is placed back in service.

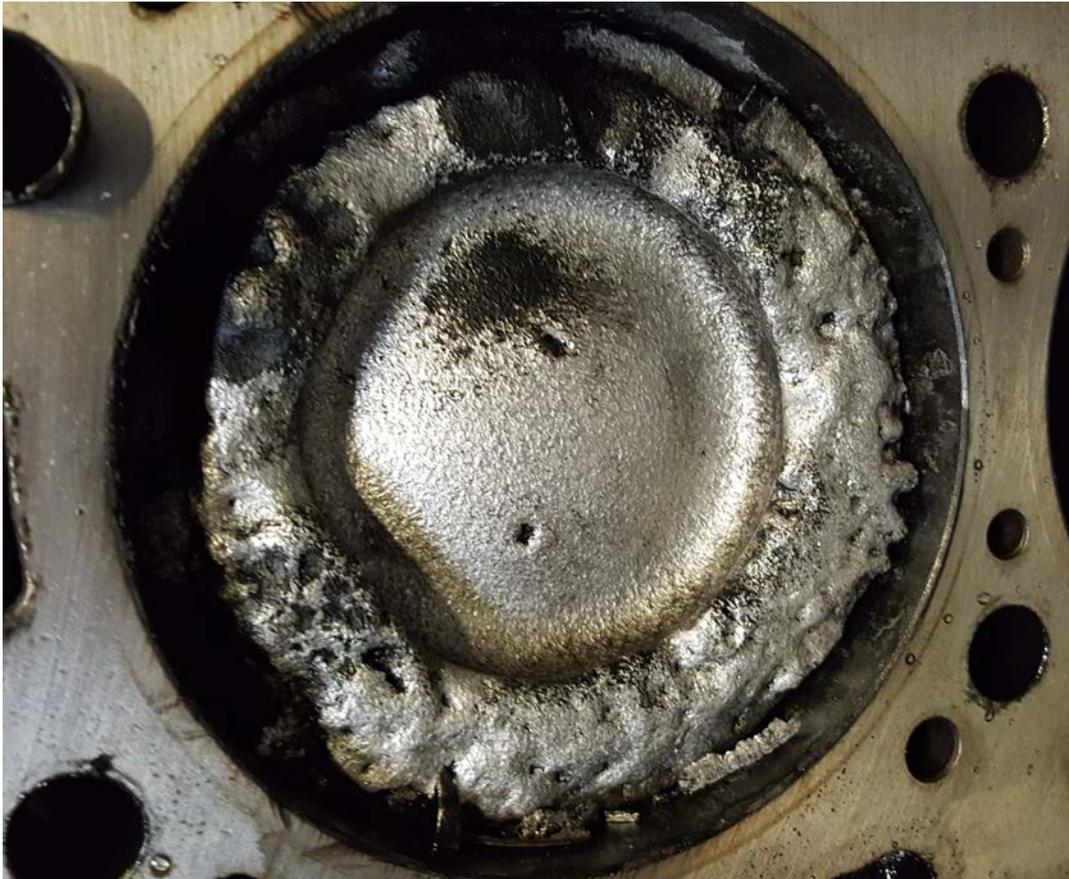
If excessive fuel is being delivered, or continues to be supplied the heat from combustion continues to rise. It's hard to stop a fire when there is fuel still being supplied. Here-in starts a snowballing effect as there is not sufficient relief of temperature inside the cylinder and in seconds the next combustion process is already starting. The additional heat/pressure/fuel will actually cause combustion to start occurring the moment compression is sufficient. This may be well before the designed 7° BTDC in this example! Continued operation will expose the piston crown to melting temperatures as the piston

shown below details. This piston may of only been running only 300° F hotter than the ones next to it, but it was beyond the melting threshold for too long of a period of time.

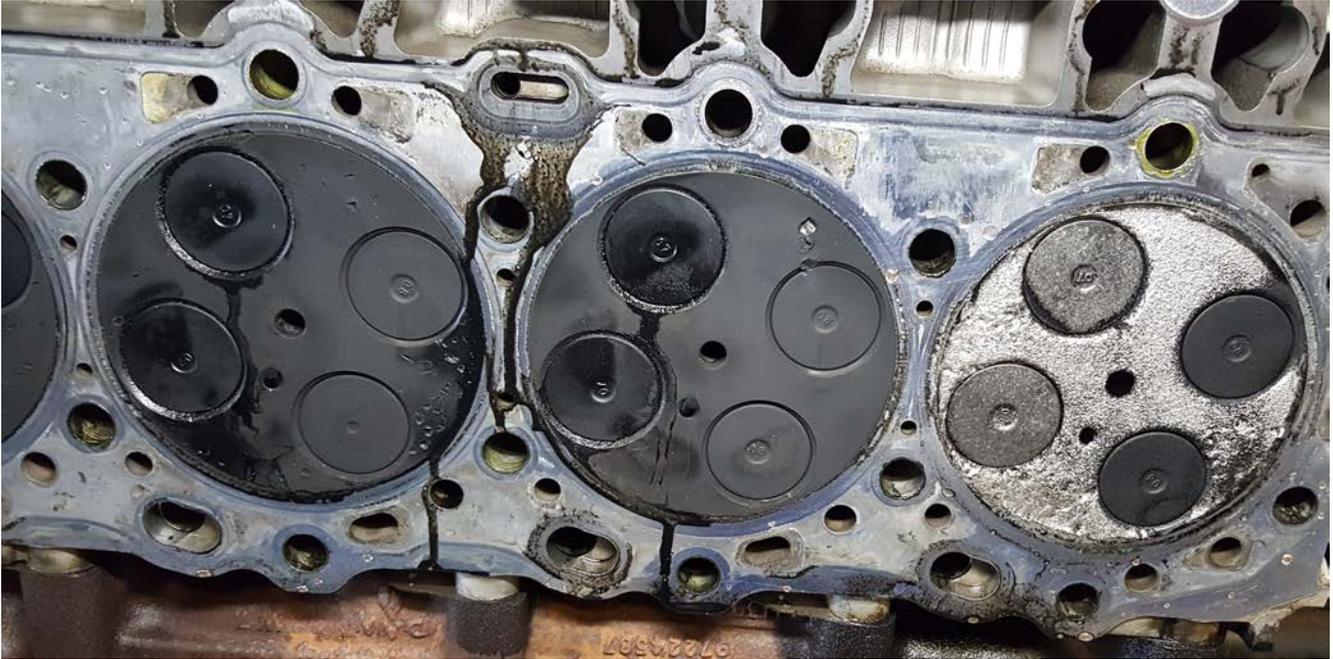
The hot molten aluminum is thrown unto the cylinder head deck from the combustion explosion and attaches itself to the slightly cooler casting. In this particular case, only one of the eight cylinders was affected and was caused by a faulty fuel injector. This occurred shortly after 8 used injectors were installed on a replacement engine without determining the cause of a previous engine failure. This engine failure could have been prevented if only; the fuel 8 injectors had been sent out to a fuel injection shop for testing.
